Manhole Inspection Summary

Manhole # S41G__014MH

Insp Date: **12/22/08 12:16 PM**

Location Address: **rear 837 s monford st**

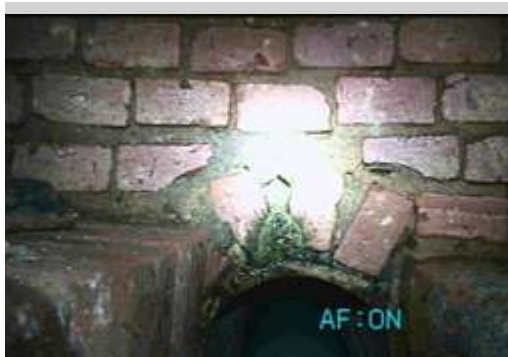
Defect 4

Infiltration: ☐ None ☐ Joint ☐ Cracks ☐ Mortar ☐ Roots ☒ **Wall**

barrel infiltration at wall

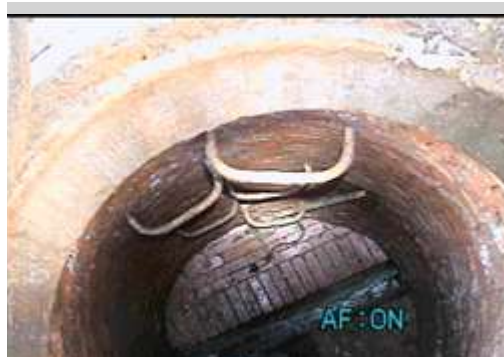
Defect 3

Count: **4** Missing: **0** ☒ **Corroded**

steps corroded

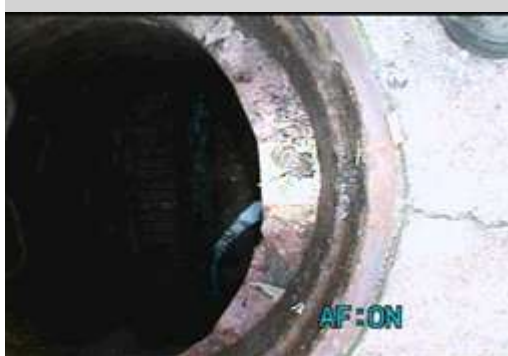
Defect 2

Offset: **4** (in.)

frame offset

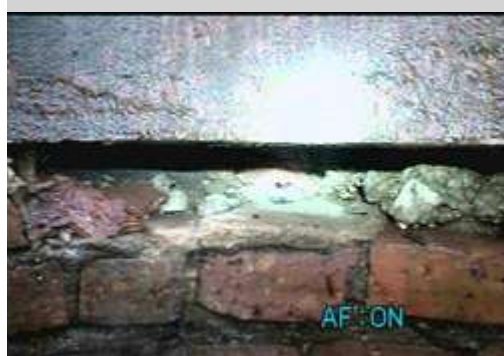
Defect 1

Condition: ☐ Sound ☐ Cracked ☐ Root Intrusion ☒ **Loose Brick** ☐ Deteriorated

chimney loose bricks at frame joint
